**Professional Analysis
and Consulting, Inc.**

Project No. 2018

**SIG SAUER, INC. AND CITY
OF CAMBRIDGE**

Date of Report: November 29, 2023

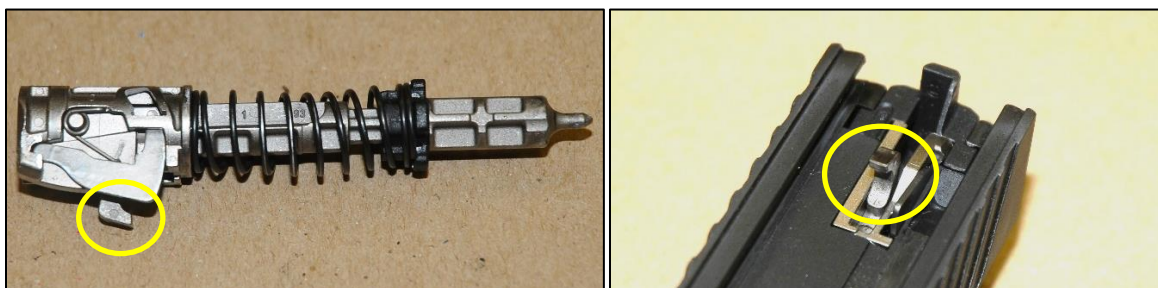
1. The sear and striker pin components, the engagement of which is a critical feature of this design, are produced using a Metal Injection Molding (MIM) process and do not have any secondary machining performed on the small engagement surfaces. These MIM-produced components have areas of excessive variability due to the manufacturing process. For surfaces where tight tolerances and consistent fit-up are required, MIM parts will typically have secondary processing, or machining, to eliminate the variation. See Figures 3 – 4.

Figure 3 - Striker assembly with striker foot circled (left), striker assembly in the slide assembly (right)

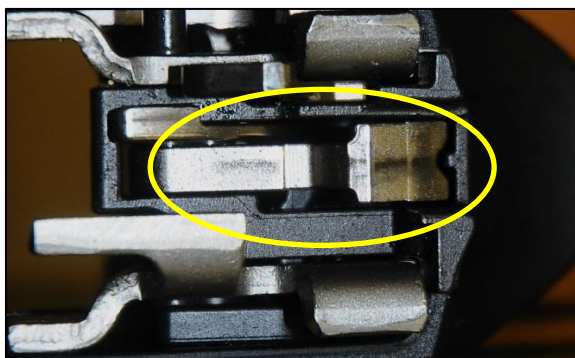
Figure 4 - Top view of sear (circled) and off-center striker drag marks

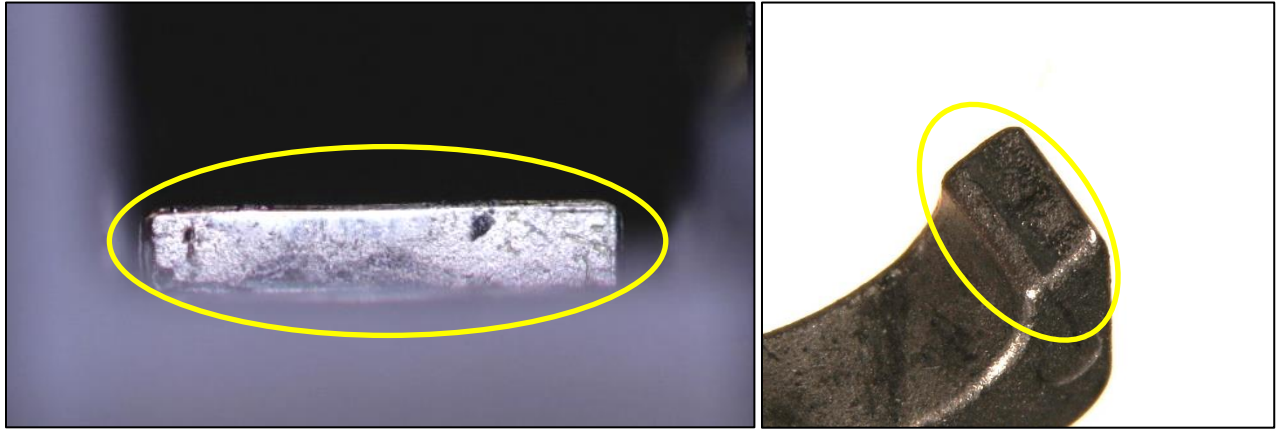
2. The sear and striker foot portion of the striker pin both exhibited inconsistencies on the surfaces that are in contact with each other, minimizing the actual contact surface area that is needed to keep the parts engaged until the trigger is pulled. In addition to the MIM as-manufactured surfaces (rough and unmachined), both parts also exhibited a raised area around the periphery of the interface surface. This has been referred to by others as rollover and appears to be a combination of flashing, radiused corners and edges, and shrinkage of the inner surface area. The end result is reduced contact surface area between both components, making the firearm more susceptible to an un-commanded discharge. Figure 5 (left) is a close-up photograph of the sear step with clear wear marks from the striker foot that shows an inconsistent pattern, including an area within the step with no wear. Figure 5 (right) is a close-up

photograph of the subject striker foot showing the raised area around the periphery of the face, radiused edges, and an unmachined surface.

Figure 5 - Close ups of sear step (left), and striker foot (right), both unmachined surfaces

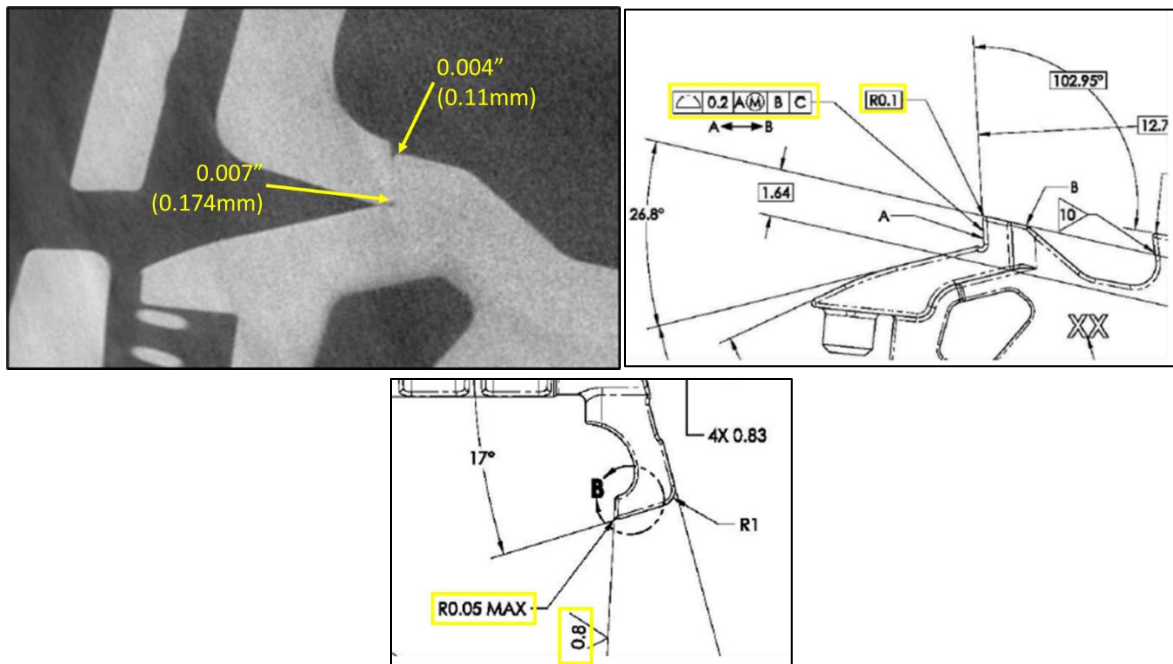
4. The CT scan was also used to document the striker and sear engagement areas as compared to the drawings, shown in Figure 8.¹¹ The sear step had the top surface, where the striker foot is released from, measured radius at 0.004" (0.11 mm), with the Sig Sauer drawing #1302192¹² indicating a radius of 0.1 mm. The surface profile where the striker engages indicates a tolerance of 0.2 mm, but as with the other components discussed in this report, this dimension could not be quantified with the CT scan. The CT scan of the bottom edge of the striker foot radius measured 0.007" (0.174 mm). The Sig Sauer striker drawing #1302193¹³ indicates that the radius on the bottom edge of the striker foot at 0.003" (0.1 mm). This drawing also indicates that the surface that engages with the sear step has a surface finish specification of 0.8, but this could not be quantified with the CT scan.

Figure 8 - CT scan of the subject striker and sear (top left), sear drawing (top right), and striker drawing (bottom)

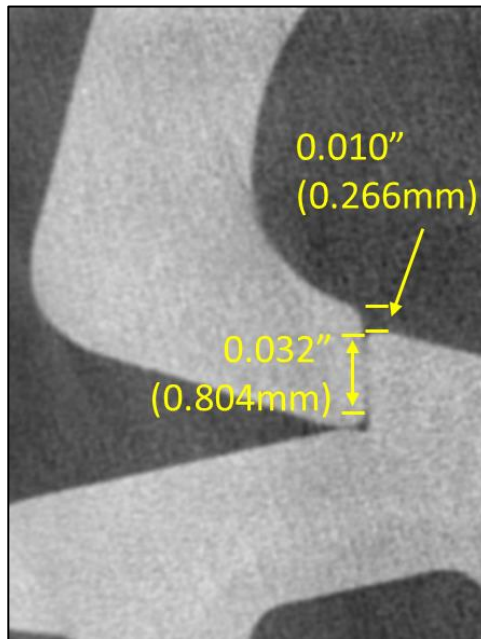
5. In addition to the lack of secondary processing on the sear and striker foot, there is also a vertical misalignment of the two parts, as shown in the CT scan in Figure 9. The striker foot is unable to fully engage with the sear face surface, reducing the area available for the engagement of the two parts. With the minimal amount of overlap and engagement between the two components, a minor amount of vibration, shock, impulse, or relative movement between the slide and the grip module would allow the striker to no longer be retained by the sear, and to move forward and discharge a round. In other words, the ongoing relative movement between the slide and the grip module, in addition to the inertia, impulses, and vibration experienced while secured in a Sig Sauer authorized holster over time, will allow the striker foot to become disconnected from the sear face, in combination with the other defects identified in this report. For reference, the contact surface area measured 0.032" (0.804 mm). No documentation has been produced by Sig Sauer that identified what the design specification is for the

contact surface area between the striker foot and the sear. An additional 0.010" (0.266 mm) is available on the striker foot for engagement with the sear, if the sear step was larger, and both striker and sear were machined to eliminate the radiused edges.

Figure 9 - Subject striker foot to sear contact surface and vertical offset

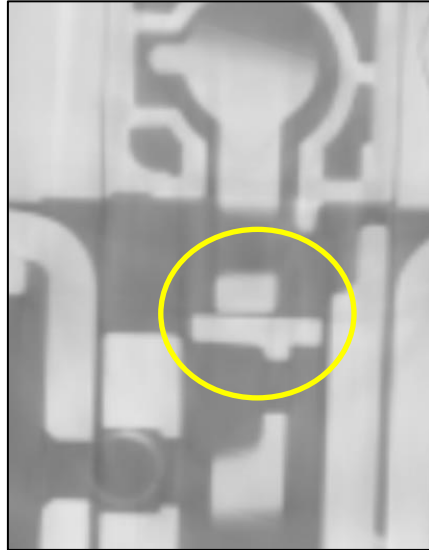
6. As shown in the CT scan below, there is also a lateral offset between the sear and the striker, causing an unbalanced force and off-center contact on the sear. This off-center contact between the two components allows the sear to be loaded laterally, causing the striker foot to make more contact on one side versus the other. When the sear is consistently loaded in one direction due to the misalignment, it contributes to reducing the actual contact surface area between the striker foot and the step in the sear. The CT scan of this offset is shown in Figure 10. Figures 4 and 5 above show the off-center and inconsistent contact area from the striker foot on the sear step.

Figure 10 – CT scan slice of striker foot offset to sear

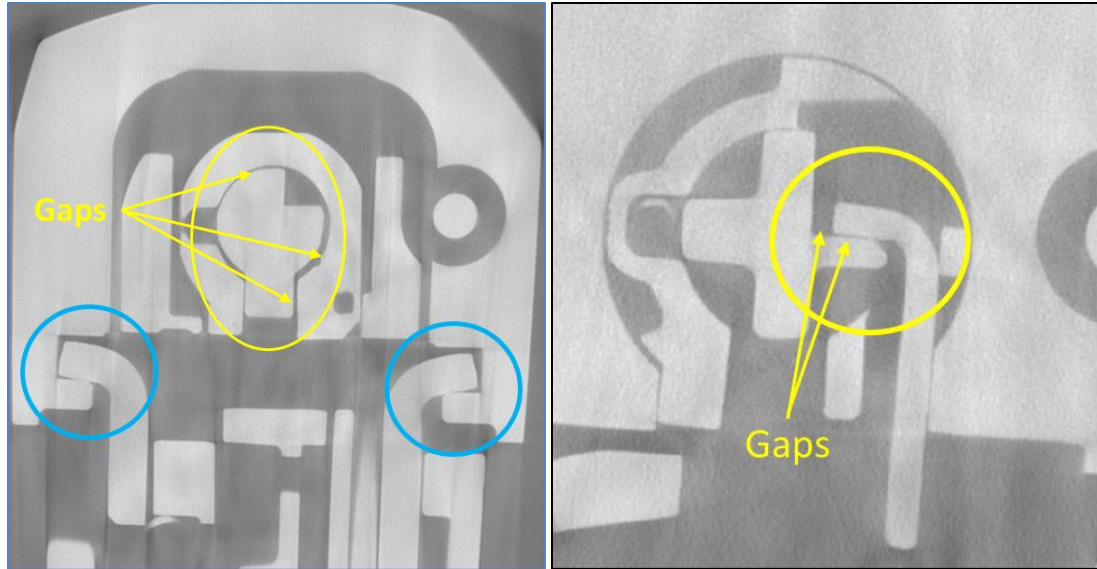
7. In looking at the rear-view CT scan slices of the striker pin relative to the housing, there are gaps within the striker housing, as shown in Figure 11 (left within yellow circle). This allows for axial rotation and movement of the striker pin within the housing each time the firearm is discharged and the slide cycles. This movement will also cause the safety lock tab that is intended to make contact with the parallel horizontal plane of the striker (striker channel) to become out of alignment, and not parallel, creating a gap. Based on the component drawings supplied by Sig Sauer, the maximum allowable angle of the striker pin to the housing is nearly 4°, however, Sig Sauer had not produced any assembly drawings that document the specification of the complete striker assembly. The misalignment and rotation will cause minimal contact between the safety lock tab and the rear vertical stop portion of the striker, thereby reducing the contact area between the two surfaces. The misalignment could allow the striker pin to continue its forward movement when the striker foot is no longer retained by the sear, in combination with the other defects identified in this report, leading to an un-commanded discharge. The misalignment of the safety lock tab to the striker pin is also shown in Figure 11 (right).

Figure 11 - CT scan view from the rear of striker gaps to housing (left) and safety lock tab misalignment to striker pin (right)

8. The CT images from Figure 11 (left) above also illustrate the slide assembly gaps to the grip module (circled in blue). These gaps allow the striker foot (as part of the slide assembly) to move vertically and laterally relative to the sear (in grip module), such as that experienced while the firearm is carried in a holster, and with vibration, impulses, and other inertial forces. The frame receiver stamping is not made to specification which contributes to the variation and fitment issues between the slide assembly and the grip module. The horizontal tabs were measured at 103.5° and 108.4° from the vertical wall, when the drawing specification indicates 90°. Also, the overall width between the slide tabs measured 21.67 mm, smaller than the 21.71 mm minimum tolerance shown on the drawing. It has been stated in previous reports for Sig Sauer that the width of the receiver stamping tabs is machined to tolerance, but no drawings have been produced that verify this information, and no evidence exists on the subject stamping.

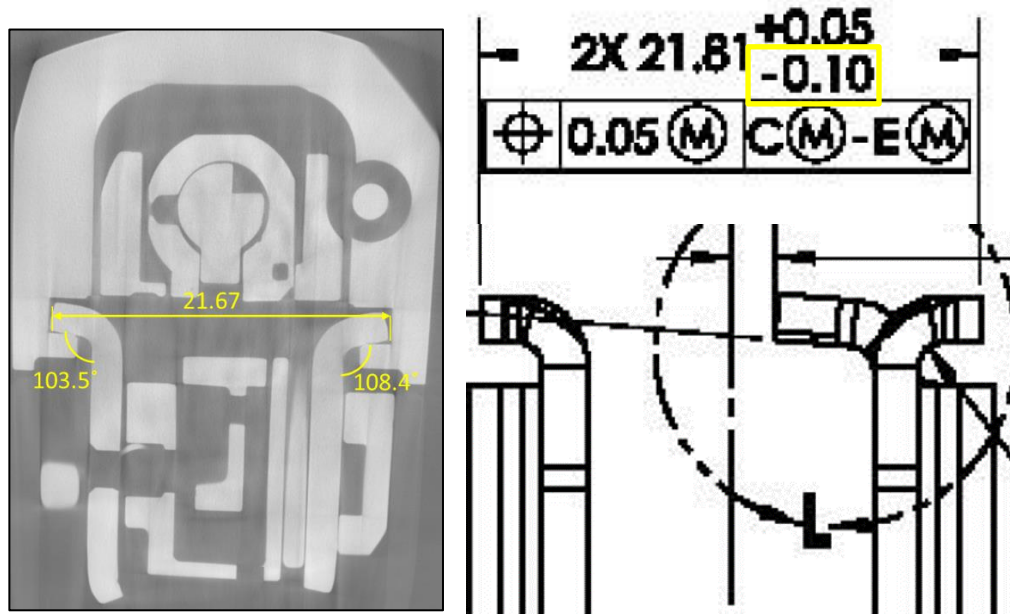
The CT scan is shown below (left) with the frame receiver stamping drawing image (right) in Figure 12. The bottom surface of the receiver tabs are shown as datum "Z" on the Sig Sauer drawing 1301552¹⁴ and all four tabs have a GD&T¹⁵ callout specifying flatness as 0.1 mm. Since none of the four tabs on the frame receiver stamping are perpendicular or flat relative to datum "Z", the frame receiver component does not meet the drawing specification. The bottom surface of the tabs also shows an inconsistent surface due to the forming process, providing for additional variation between the slide and grip module.

Additionally, the slots machined in the slide where the four frame receiver tabs are retained measured 0.089" (2.28 mm). The slide rail slots measured 2.27 mm and 2.26 mm with a digital caliper. However, as the slide slot dimensions or tolerances are not identified on any of the slide machining drawings produced, this measurement taken could not be compared with the specification. If these slots were also out of specification (too large), then this would also contribute to the amount of variation and play (sloppiness)

between the slide assembly and the grip module. The frame receiver material thickness was measured between 1.72 and 1.98 mm, with a minimum of 1.9 mm specified on the Sig Sauer drawing.

Figure 12 - Receiver stamping measurements from CT scan (left), Sig receiver drawing #1301552

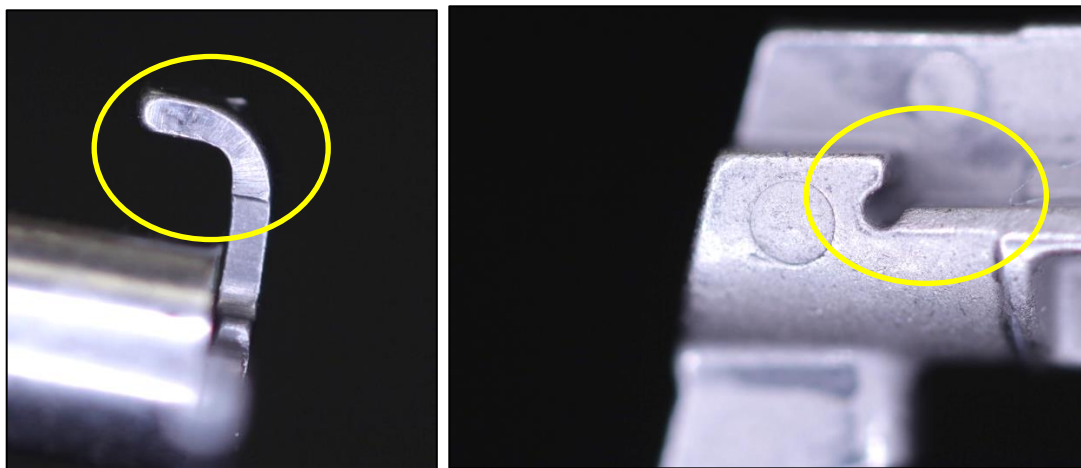
9. In addition to the issue related to the missing safety lever return spring, as well as the misalignment of these safety lock and the striker components, there were also issues noted with the safety lock and the striker stop components. The tab portion of the safety lock had an inconsistent surface, due to being a stamped steel part and unfinished on the area that would engage the striker stop, shown in Figure 13 (left). Correspondingly, the striker stop surface was rounded and unfinished (MIM), as shown in Figure 13 (right). The combination of these two poorly manufactured surfaces would allow the striker to not be restrained by the safety lock, when the striker becomes disconnected from the sear, allowing an un-commanded discharge.

Figure 13 – Exemplar P320 firearm - manufacturing issues with the safety lock tab (left) and the striker stop (right)

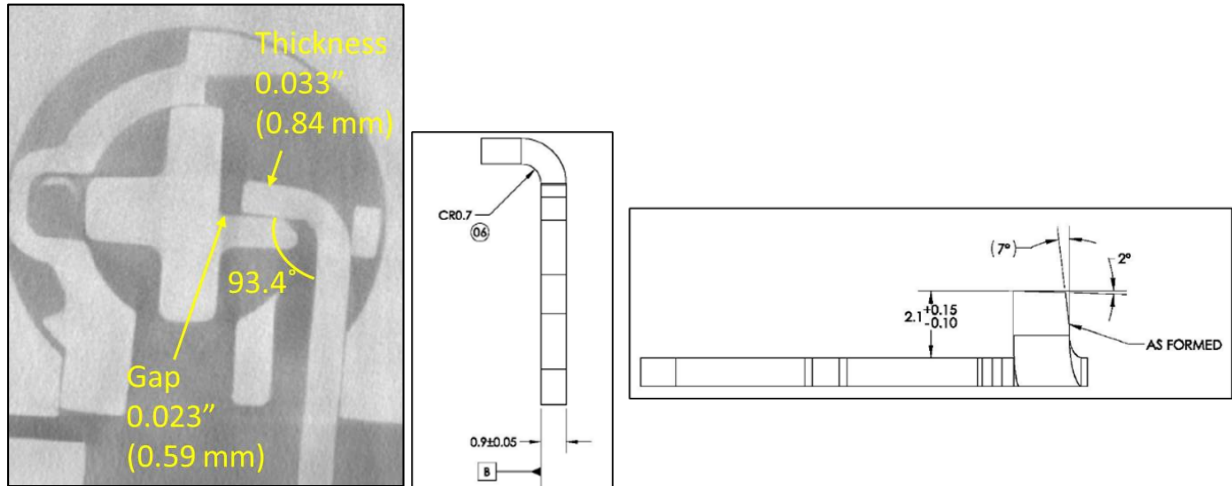
Additionally, the CT scan was utilized to quantify certain safety lock and striker stop measurements. Figure 14 shows the CT scan measurements for the safety lock (left) and the corresponding area from the Sig Sauer drawing #1301029¹⁶ (center and right), which show the safety lock tab is not formed properly at 93.4°, with the drawing indicating 90°. The profile of the surface shown in Figure 13 (left) of the safety lock tab example, that is intended to come into contact with the striker stop, has a tolerance specified as .008" (0.2 mm). The actual surface quality could not be measured with the CT scan, but it does not appear to visually meet the drawing specification. The thickness of the safety lock material in the area intended to contact the striker stop measured 0.033" (0.84 mm), below the drawing specification minimum of 0.85 mm.

Figure 14 - Safety lock image from CT scan (left), and images from Sig Sauer drawing of safety lock (center and right)

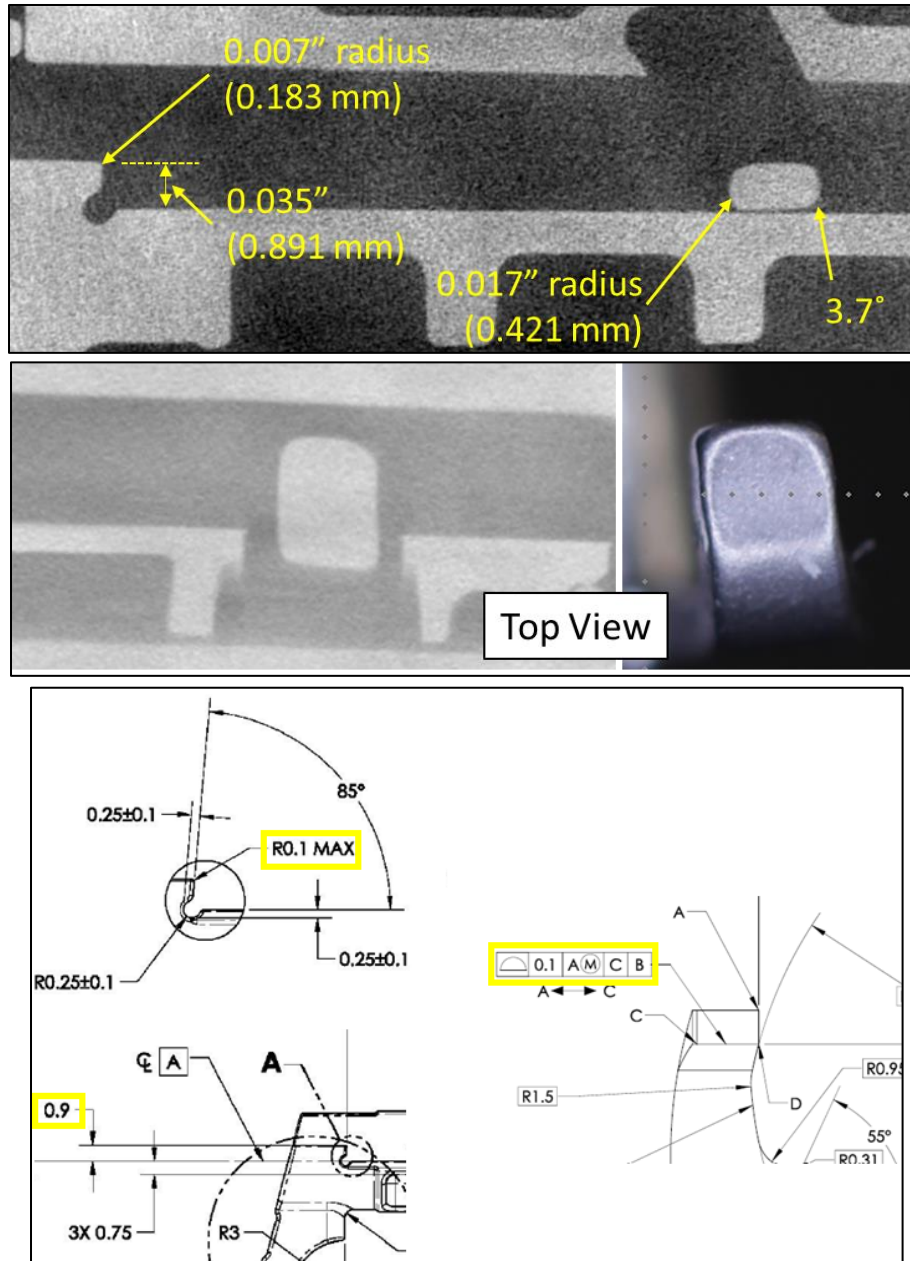
The CT scan was also used to measure and quantify the safety lock and striker stop from a side view. Figure 15 shows the CT scan measurements for the striker stop and safety lock (top and center) and the corresponding area from the Sig Sauer drawings (bottom). These images show the safety lock tab is not formed properly since the 3.7° gap is beyond the surface profile designation on the Sig Sauer drawing¹⁷ of 0.004" (0.1 mm). The striker stop has a 0.007" (0.183 mm) radius profile and is 0.035" (0.891 mm) high, compared to 0.004" (0.1 mm) and 0.035" (0.9 mm) respectively, from the Sig Sauer drawing #1302193,¹⁸ shown in Figure 15 (bottom).

Figure 15 - CT scan of striker stop and safety lock (top), top views of same parts (center), Sig Sauer drawings of the same parts (below)

Since the thickness of the safety lock is specified as 0.035" (0.9 mm), the combination of the quality issues discussed above, misalignment of the striker and safety lock, and possible contact from the safety lever (since the return spring has been eliminated), means that with less than 1 mm of displacement, the safety lock will not be in a position to stop the striker from moving forward if the striker becomes displaced from the sear without the user pulling the trigger. This also assumes that the parts are made to the drawing specification, which they are not, in the subject firearm. The out of specification items described with the safety lock and the striker stop reduces the amount of displacement required to cause the safety lock to fail to stop the striker from contacting the cartridge in the chamber.

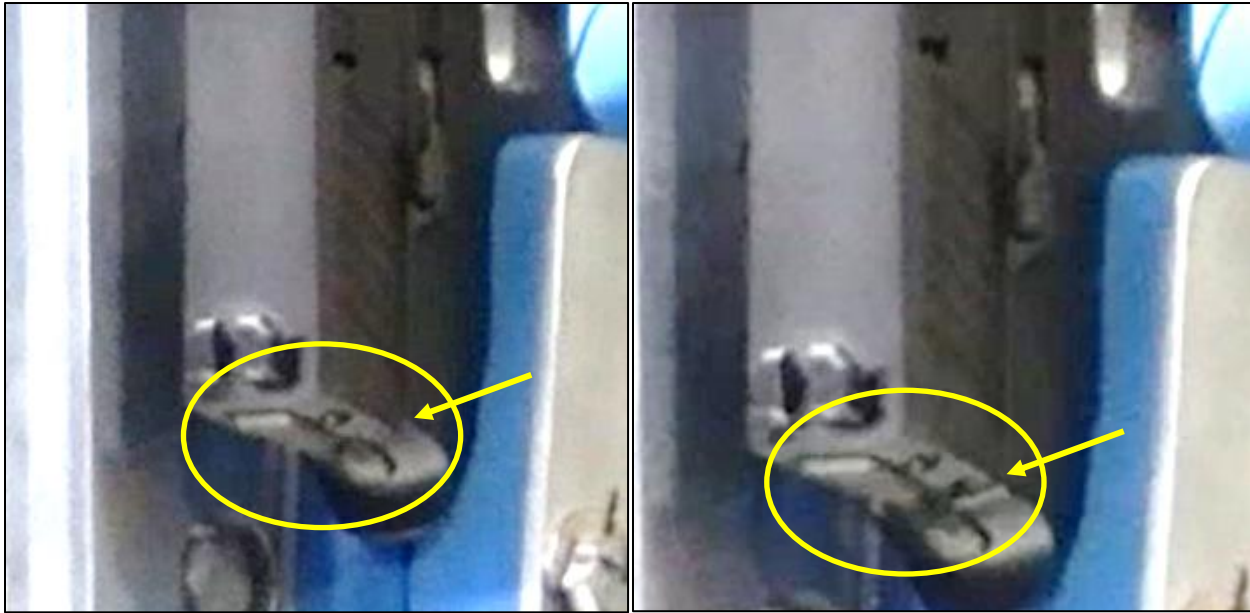
The first tests performed were the vibration tests, which included sinusoidal vibration at various frequencies, and shock (jolt) testing. While the summary report from the testing facility states that no primers were struck, there were several instances of significant movement between the slide assembly and the grip module, with a couple of examples shown in Figures 16 and 17.

Figure 16 – Sig Sauer Vibration #1 Test #3 Showing slide moving relative to grip module

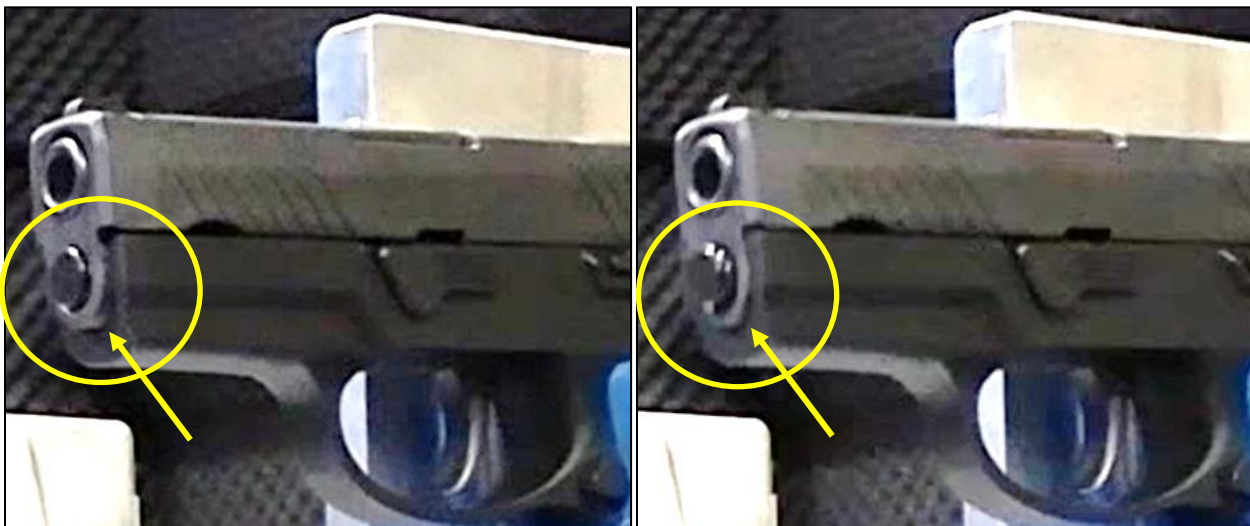
Figure 17 - Sig Sauer Vibration #2 Test #2 Showing slide movement relative to the grip module

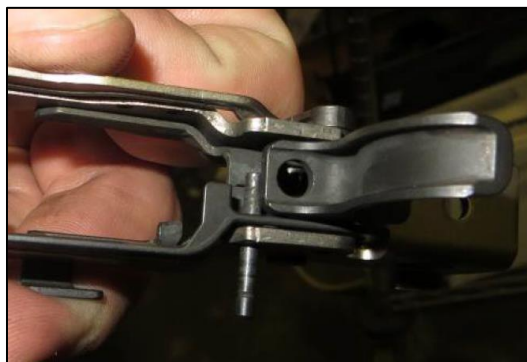
Additionally, the vibration test #1, iteration #3 had a trigger stop pin become displaced, as shown in Figure 18.

Figure 18 - Vibration Test #1 Iteration #3 Photo #66 showing trigger stop pin displaced
